# Manhole Inspection Summary

Manhole # S35SS1067MH

**Location** Address: **5207 TABARD CT**

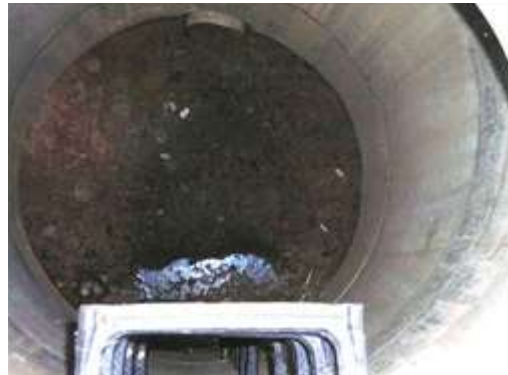
Top View

Channel debris.

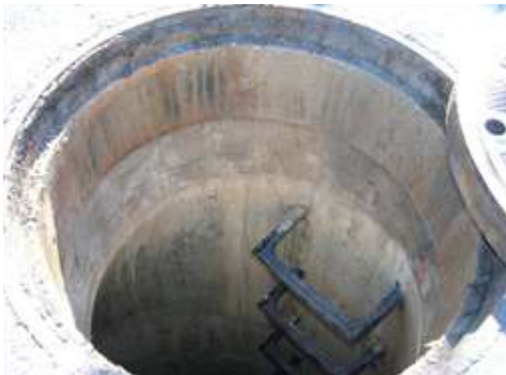
Defect

☒ **Leaks**

Infiltration: ☐ None ☒ **Joint** ☐ Cracks ☐ Mortar ☐ Roots ☐ Wall

Frame leaks. Adjustment and Corbel infiltration - other side.

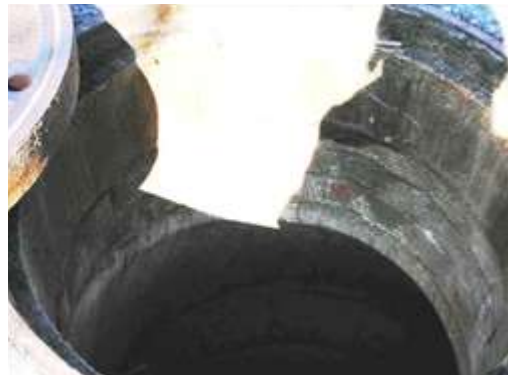
Defect

Frame leaks. Adjustment and Corbel infiltration.

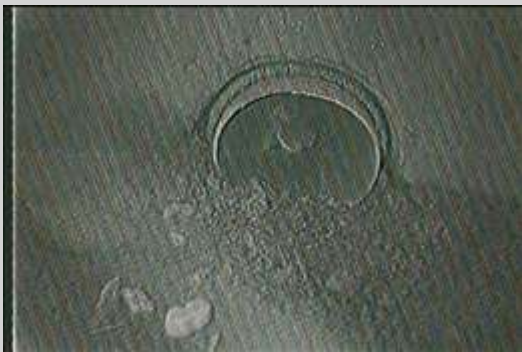
10 in. Circular Gravity Sewer  
Pipe Out @ 12 O'Clock

Deposits: ☐ None ☒ **Mud** ☐ Sludge ☒ **Debris** ☐ Grease

Silt Depth: **1** (in.) Deposits Extent: **Light**

Infiltration: **Evidence** Pipe Seal Cond: **Unknown**
